To: Mr. James Heid, Albion Bridge Stewards

FROM: Abolhassan Astaneh-Asl, Ph.D., P.E.

Date: September 9, 2024

Subject: Review of the 2023 Caltrans Inspection Report
on the Albion River Bridge

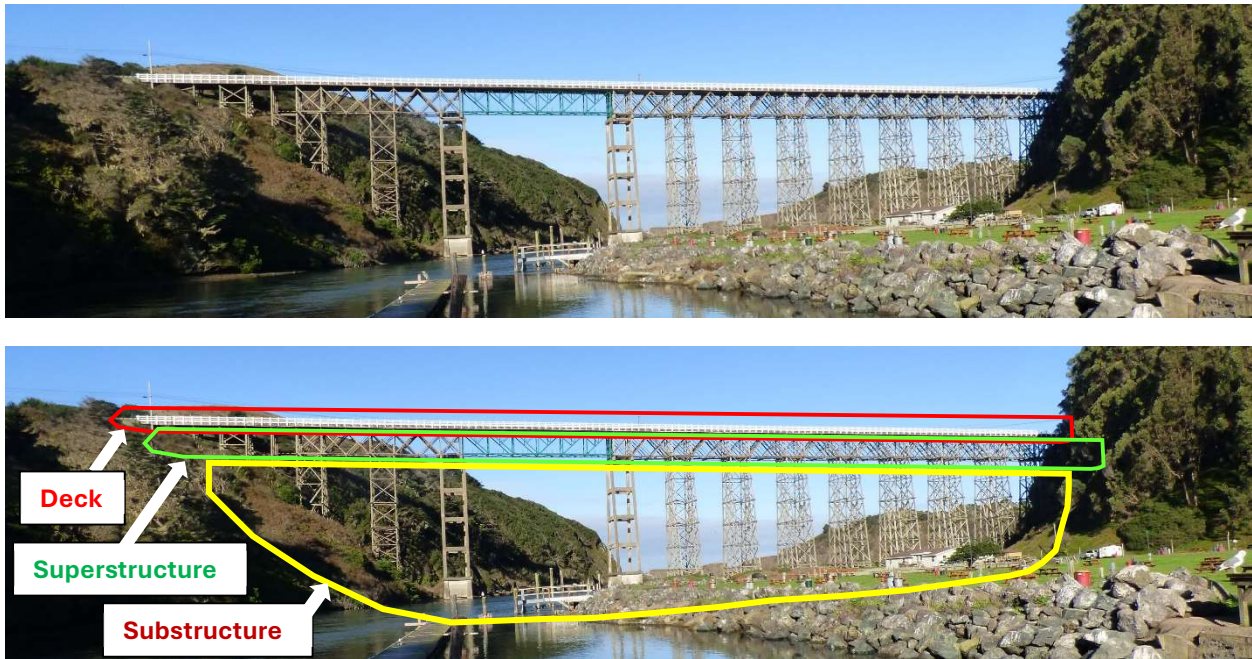
Figure 1 Deck, Superstructure, and Substructure of the Albion River Bridge

The three main parts of bridges are the Deck, Superstructure, and Substructure. I have shown these three parts of the Albion River Bridge in Figure 1 below. The Deck is the structure that supports the roadway. Usually, there is an asphalt overlay on the Deck. The Albion River Bridge's Deck is made of timber and has a two-inch asphalt overlay. The Superstructure is the structure that supports the Deck. For the Albion River Bridge, the Superstructure consists of two steel trusses in the main span over the river and timber trusses in the other 33 spans, which are called approach spans. The Substructure is the structure, such as piers, columns, foundations, pile caps, and piles. For the Albion River Bridge, the Substructure is made of concrete 4-legged

towers to support the main span and timber towers to support the trusses of the approach spans. The towers are supported on the foundation system.

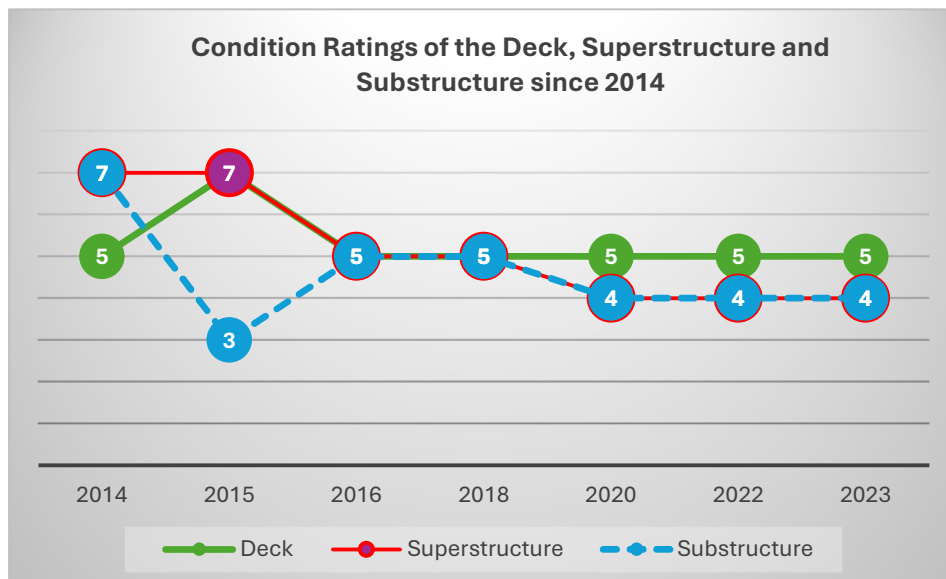
The chart below shows Deck, Superstructure, and Substructure condition ratings variations. In 2014, the rating of the Deck was 5, and the Superstructure and Substructure rating was 7. In 2014, after the author questioned assigning the rating of 5 to the Deck, Caltrans indicated widespread rot in the Deck. However, after actual testing and sampling of the Deck, Caltrans

in 2015, agreed that the Deck was in good condition and raised the rating of the Deck to 7. However, at this time, the condition rating of the Substructure dropped from 7 to 3. It is almost impossible for a bridge condition rating to drop from 7 to 3 in one year without experiencing a major damaging event such as a strong earthquake or major flood. This indicates somewhat arbitrary assignment of the condition ratings to the three main parts of the bridge.

Then, a year later, in 2016, all three ratings were 5 (Fair) until 2020, when the rating of the Superstructure and Substructure dropped to 4(Poor). This assignment of Poor condition rating to the Superstructure and Substructure was after the new changes in the National Bridge Inspection Standard were introduced, which meant if the condition rating of one of the three main parts of the bridge is less than 5, the condition of the entire bridge is rated as Poor, which makes the bridge eligible for Federal funding for repair, retrofit, and replacement.
