Fire Tower Engineered Timber, Inc.

Albion River Bridge Preliminary Condition Assessment

24 August 2018

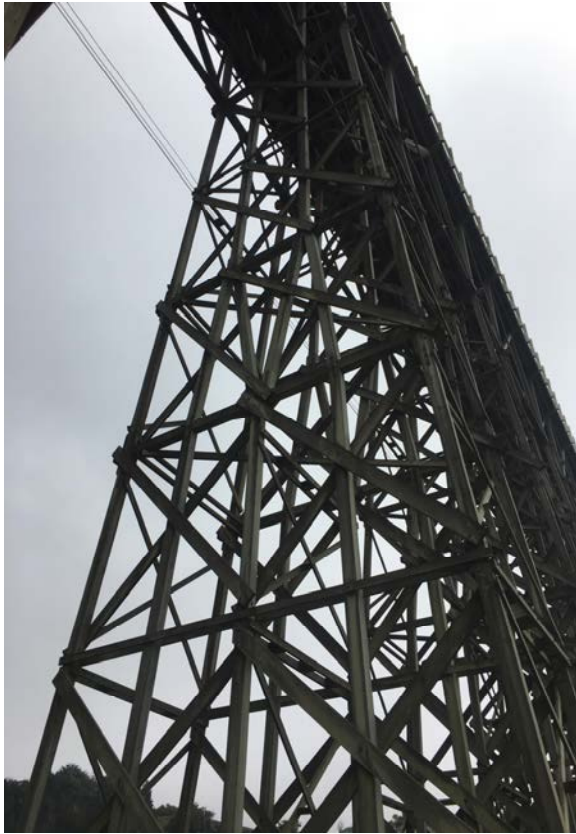
- The battered columns provide a base that is wider than the bridge deck, thus enhancing the ability of the bridge to resist lateral loads, such as those from wind. (Figure 2 below.)

Figure 1: Battered columns provide wide base below roadway

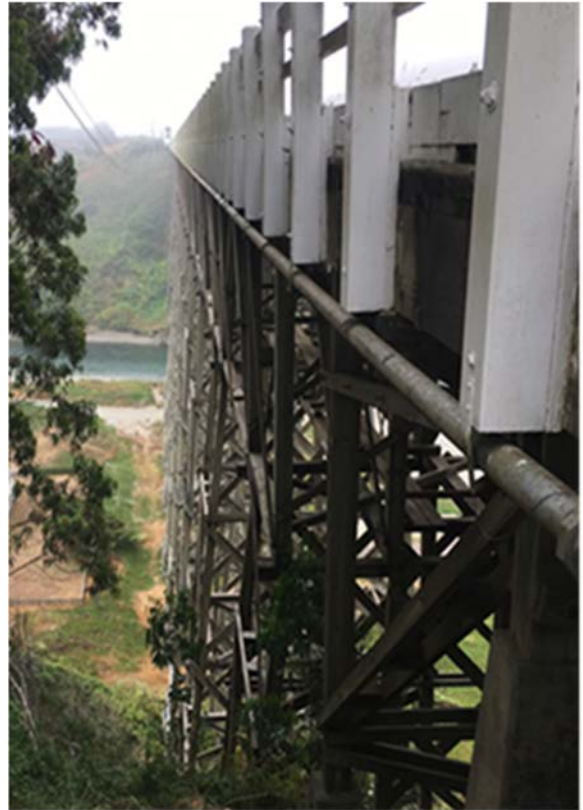
- The dimensional integrity of the bents in the trestles is impressive. Column lines are straight (to the eye) and the bents are planar. (Figure 1 below.)

Figure 2: Good dimensional integrity of trestles

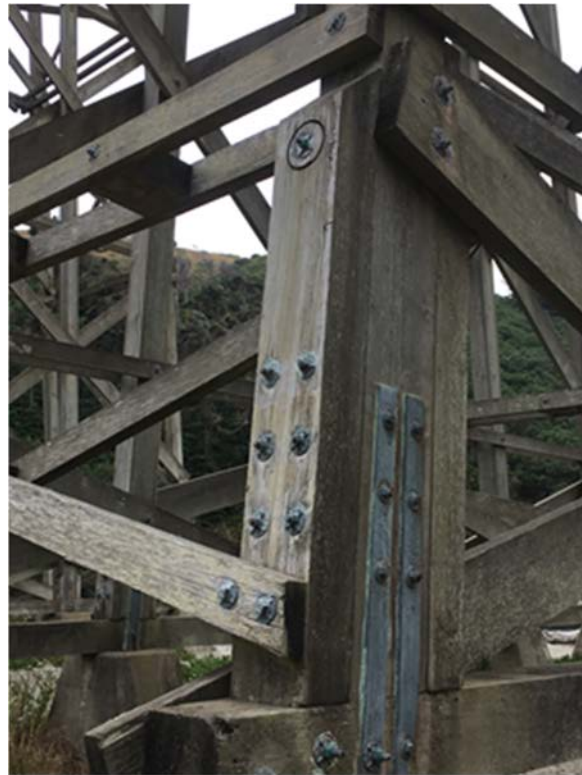
- Each of the outer-most columns of each bent is heavily bolstered at its base to help distribute compressive load into side-grain bearing on the lower sill plates. The next, inboard line of columns is lightly bolstered, because those columns carry less compression under lateral load. The bolsters appear to be effective in controlling overstress of the sill plates, as we observed no indications of localized crushing due to compression perpendicular to grain. (Figure 3 below.)

Figure 3: Bolstered exterior columns
